E5000-Leaking Out of the Packing

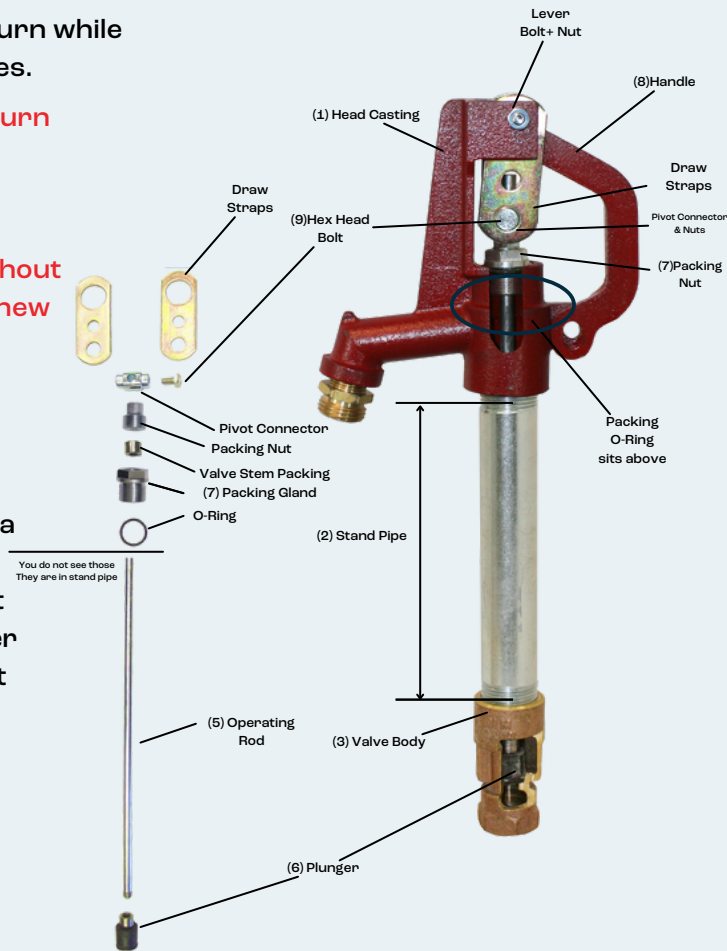
Tighten the packing nut (7) by a ¼ (quarter) turn while moving the handle (8) up and down a few times.

If this does not completely stop the leaking, turn the packing nut (7) another ¼ (Quarter) turn while moving the handle (8) up and down. Sometimes this may have to be repeated, depending on how long the leak has gone without being fixed. If not fixed after 3 adjustments, new packing needs to be added.

Small adjustments are much better than turning the nut a half or full turn or more right away, as only a little adjustment may be necessary. If the adjustments do not cure the leak, a new packing piece must be installed under the packing nut, please follow those directions to do that task. There is no reason to shut off the water to do this adjustment.

There is no reason to ever dig up a hydrant to fix it for a leak. The only circumstances a hydrant would need to be dug up would be damage to the valve body or standpipe due to freezing weather or aggressive soil conditions and it rusted through. No amount of adjusting will fix this and those parts would need to be replaced. It's highly unlikely that a hydrant needs to be dug up to be fixed.
