# E5000-Leaking Out the Nozzle/Spout

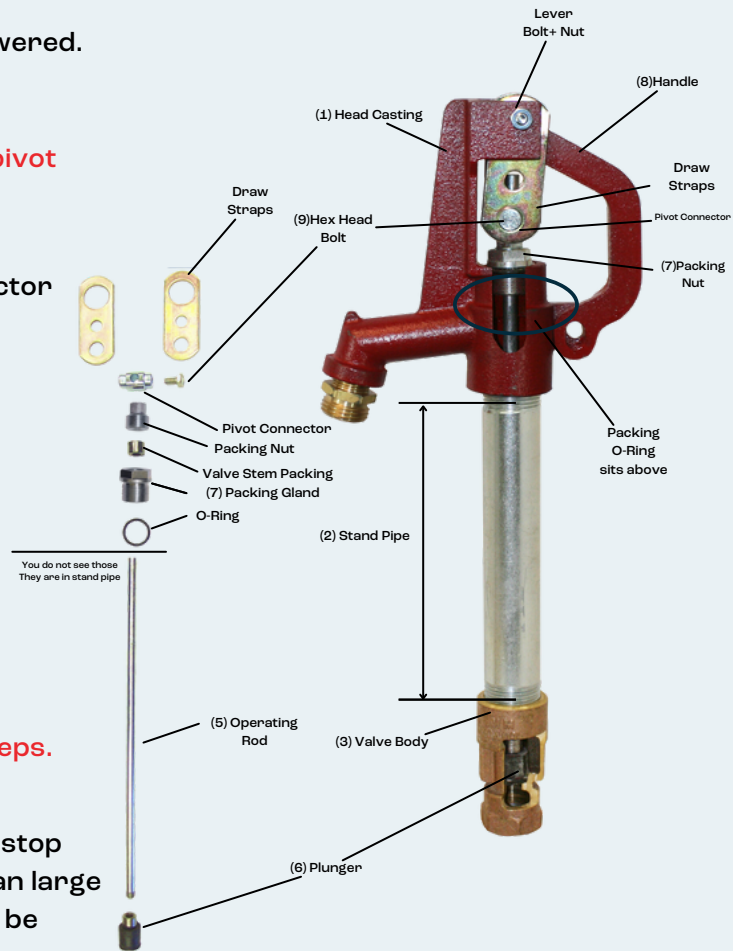
To do this, the hex head bolt (9) holding the pivot connector in place needs to be loosened.

If three or so adjustments do not fix the leak, the plunger (6) may be replaced. Most likely it is damaged, worn excessively, or debris under the plunger in the valve body.

This would mean the plunger needs to be lowered.

Once the nut is loose, move the pivot connector down slightly.

Tighten the hex head nut.

Turn the hydrant on, then off.

If the leak is still present repeat previous steps.

This may need to be repeated to completely stop the leak. Smaller adjustments are better than large adjustments, as only a little adjustment may be necessary.
